STATE OF MAINE
DEPARTMENT OF TRANSPORTATION

CONSTRUCTION REPORT

**EXPERIMENTAL INSTALLATION OF GEOSYNTHETIC PAVEMENT
REINFORCEMENT TO REDUCE REFLECTIVE CRACKING**

**RUNWAY 17-35 OVERLAY, AUBURN/LEWISTON MUNICIPAL AIRPORT
SAIP11.7001(33)**

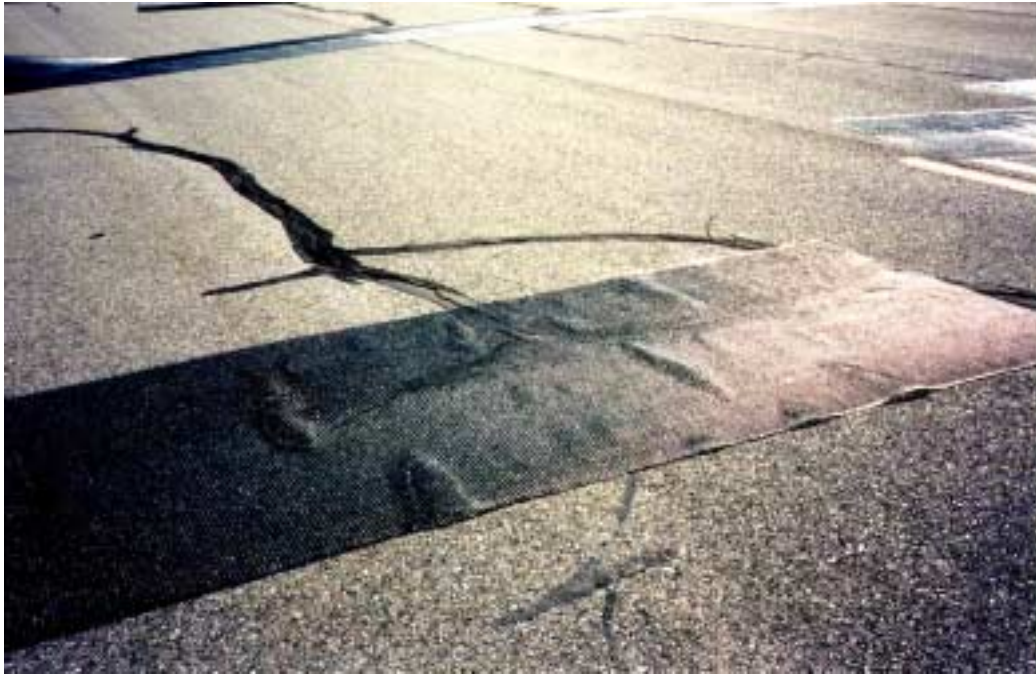
Figure 5

A problem was encountered with fabric adhesion in a few areas. The contractor made a few passes with a rubber tire roller after placing the fabric, but apparently did not roll it enough to fully activate the “glue” intended to make the material stick to the surface. A more thorough job of rolling might have prevented these problems, but even as applied the fabric only lifted in

a few areas, and adhesion was only a minor problem. Construction techniques are shown in the series of photos on the next pages.

Figure 5. Apparent Air Pockets in Fabric

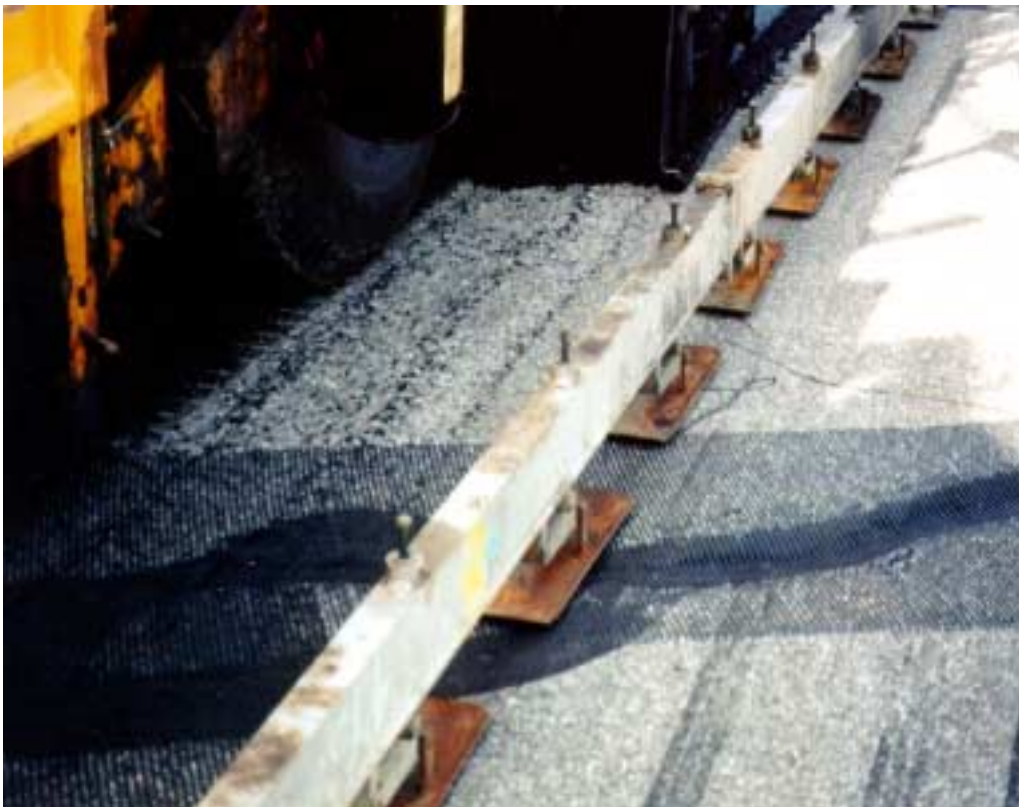
Figure 10

Figure 10. Shim Course over Fabric

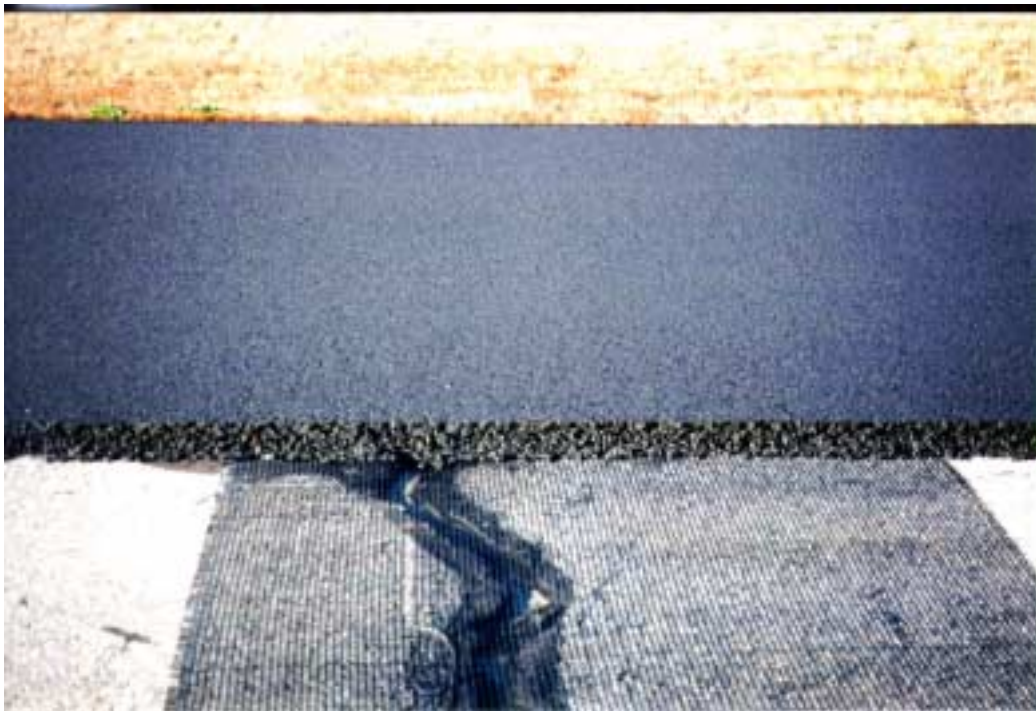
Figure 14

Figure 14. Close-up of Fabric and Pavement

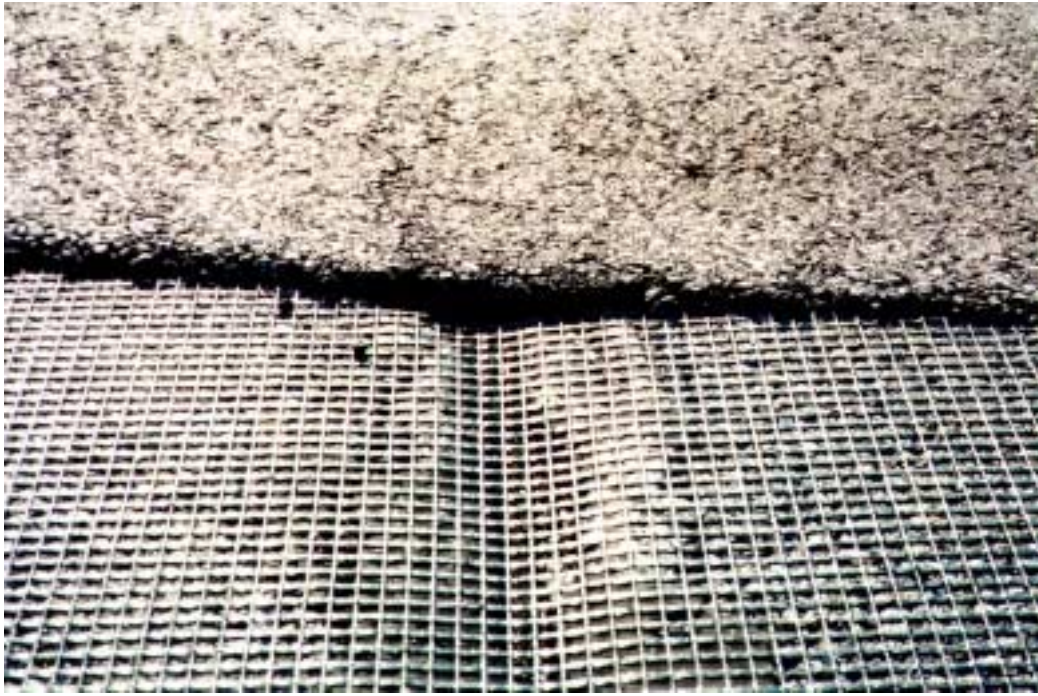
Figure 15

Figure 15. Close-up showing Extremely Deep Crack

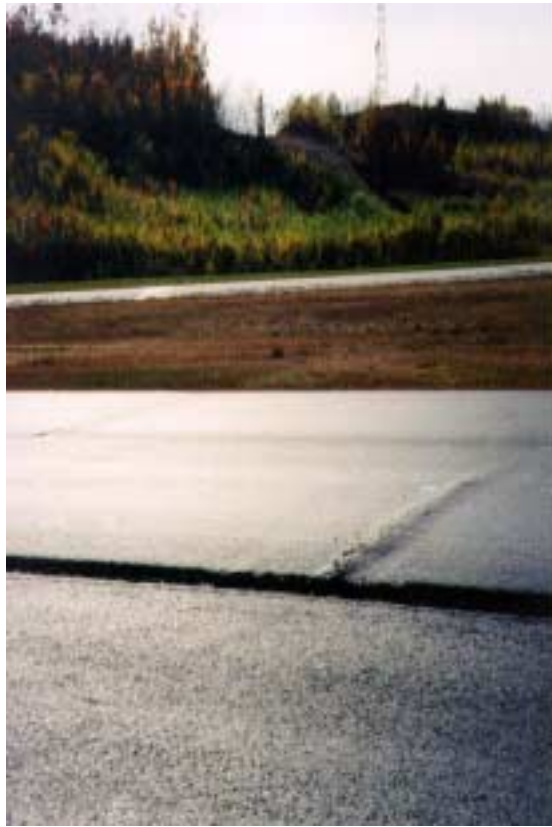
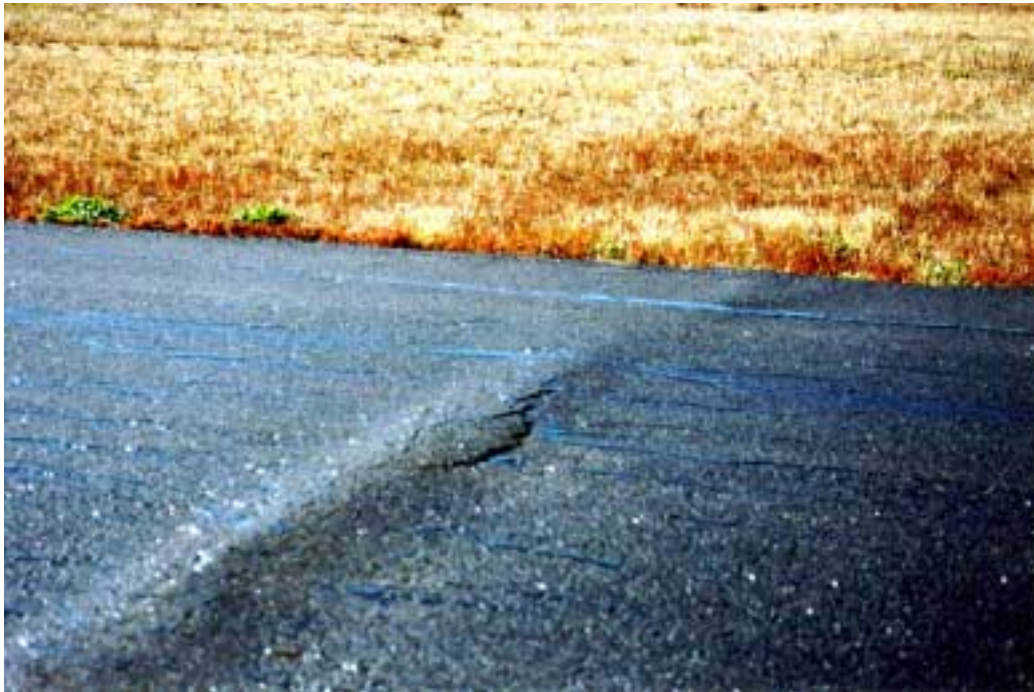
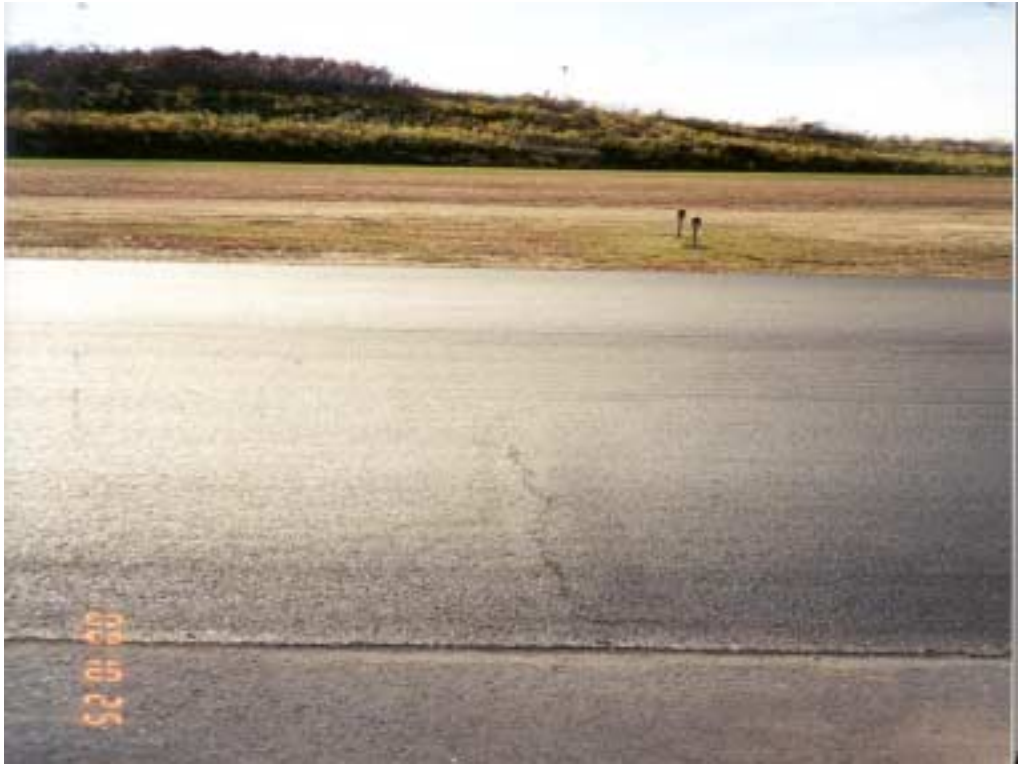
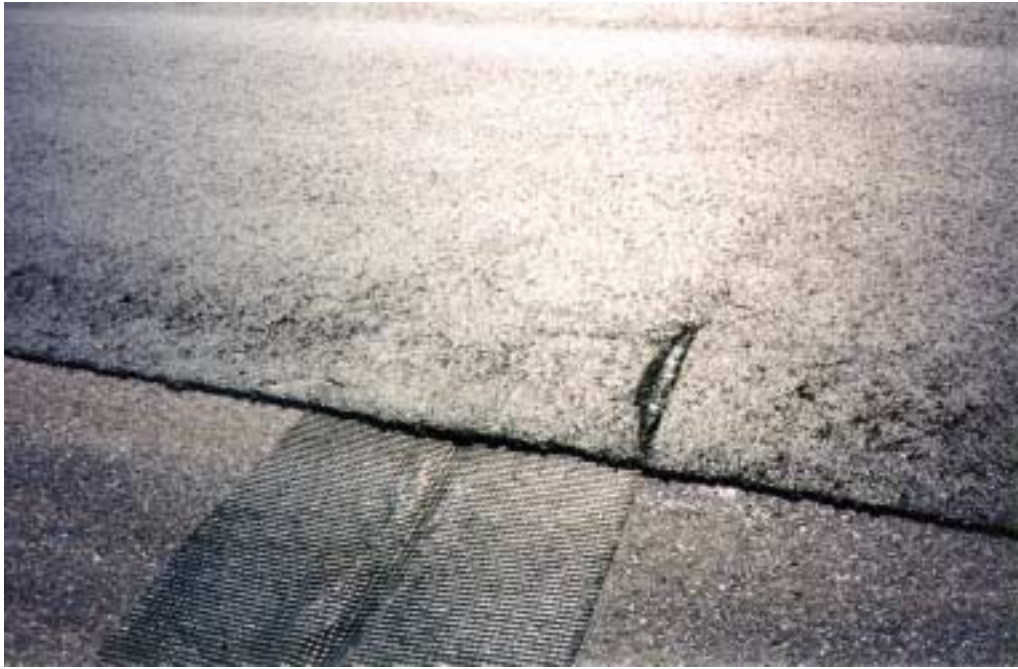
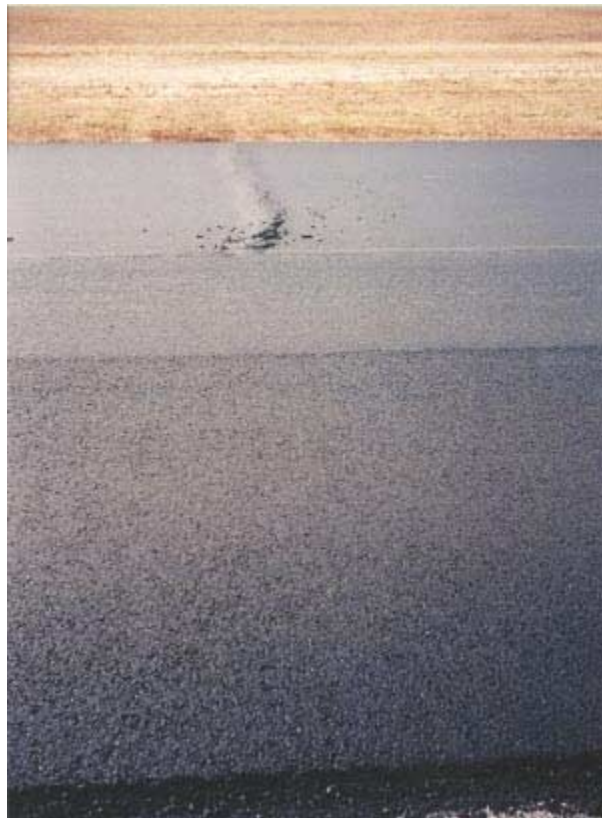
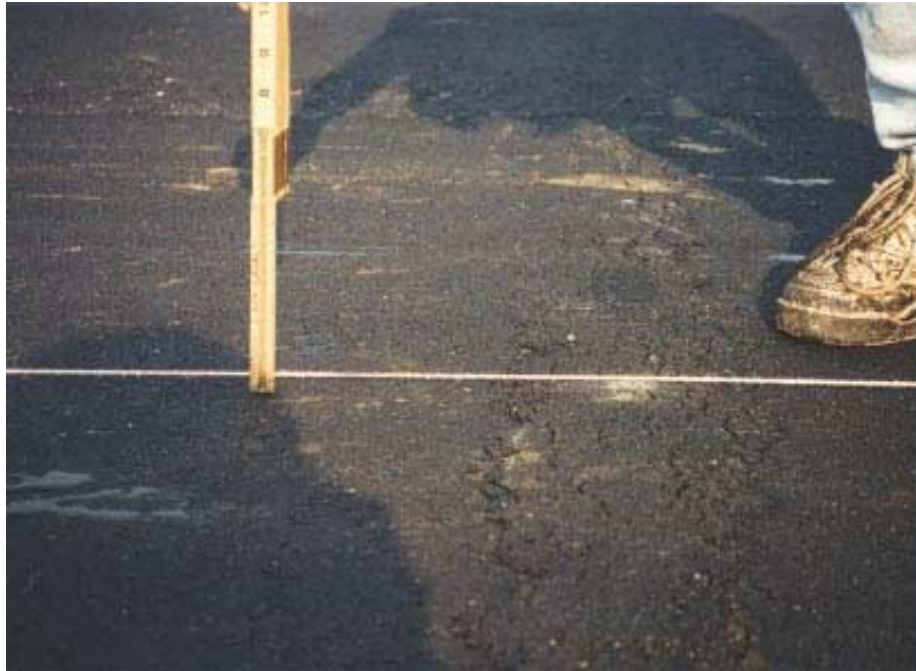
The original plan was to place a single 40 mm lift of HMA, but as the first paving lane was placed problems surfaced. It appeared that the crack sealant reacted with the HMA as it was compacted, liquefying and holding heat, so that a “bubble” was formed above the crack. This led to shoving or creeping as the HMA compaction continued. Two paving lanes were placed with the full depth overlay, as the contractor tried various compaction techniques to alleviate the problems. However, none of the techniques worked, and in the end a 15 mm shim lift was placed on the remainder of the runway width. Also, the contractor was directed to mill the two lanes placed full depth back to 15 mm in preparation for placing a 30 mm wearing course of HMA over the entire width of the runway. After placement of the shim the remainder of the project went smoothly. The milled area extended over the westerly 24 foot portion of the test area, from the south end to the intersection with the main runway.

Figure 16. - Figure 21. Ripples in the Full Depth Layer (prior to Milling and Placement of 30 mm Wearing Course)

MDOT has occasionally encountered similar problems on highway overlays. The problem seems to occur most frequently where a wide overband of sealant covers the crack area. In these cases a shim lift has been used effectively, and it appears that allowing the shim to cool before placing the wearing surface stabilizes the sealant material. Another option would be to mill 6-7 mm off the surface of the cracks, thus removing the sealant overband.

Because of the construction problems, the effectiveness of this test will be somewhat compromised, especially on the two westernmost paving lanes. However, the test area will be monitored along with the control. In the future airport overlays will be accomplished with a 15mm shim and a 30 mm wearing surface where large cracks with extensive sealing are present.

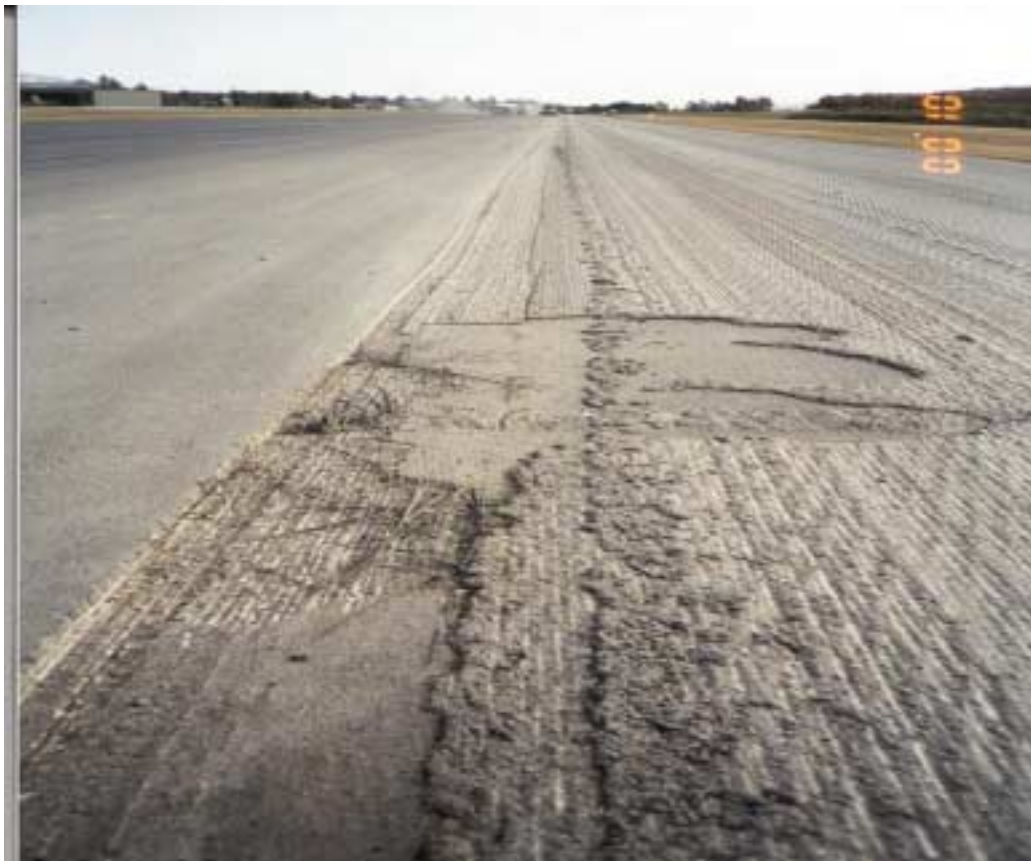
Figure 22

Figure 22. Milled Portion of Runway
